Body BORGWARD "Isabella"

Eventually existing leakages after body repairs of our type "Isabella" must be rectified as follows:

Carl F.W. B o r g w a r d G.m.b.H.
Service Dept. - Technical Service

Bremen, Germany, October 25th, 1960

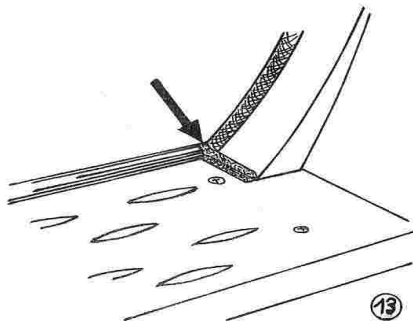
13. Water entrance at the ends of the foot board batten.

Move carpet bulge a little away from foot board batten and seal corners (see arrow fig. 13) with sealing compound.

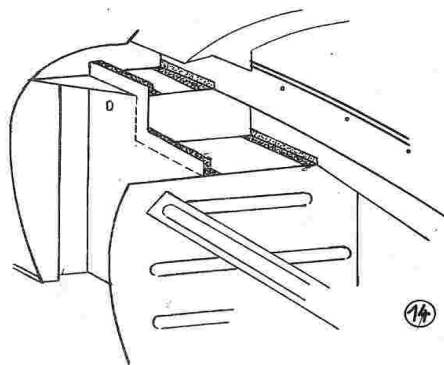
14. Water entrance between door and front wall

- a) - on cable lead-in for interior light.
- b) - on the upper edge between front wall and front wall side part.

- a) Remove bulkhead and fit cable in sagging position.
- b) Smear edges (fig. 14) with sealing compound (supplements pos. 12).

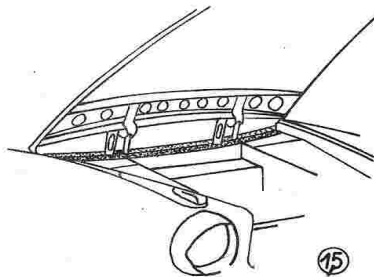
15. Water entrance on front wall (see also pos. 8).

Seal full width of upper flange edge of front wall with sealing compound (fig. 15).
