AUTOMOBIL- UND MOTOREN-WERKE  
BREMEN - GERMANY

## Trunk Lid "Isabella"

**A**  
**216**

Bremen, August 20th, 1957

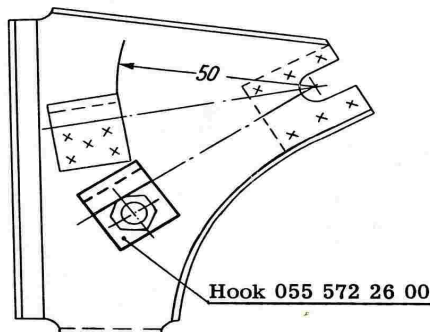
It now has become apparant that in case of special load of the trunk lid by attachment of lamps, illuminated identification shields etc. the torsion bar springs partly cannot take up this addition of weight. The trunk lid does not remain in opened position then but turns back again.

As shown in above drawing the attachment of the hook is made with a bolt, spring washer and nut (M 6) each. For this purpose the supporting brackets must be drilled, which is efficiently done with the aid of a drill extension from the center of the trunk support. The retightening of the torsion bar springs is made by clamping of the offset ends in these hooks.

In such cases this can be easily rectified by fitting of an additional hook on both sides on the supporting brackets for the springs.

It is also recommended to make these alterations in case of springs, which have no longer sufficient tension.
